Subject: Vibration Impact Assessment
Tie Line 649 Wood to Steel Replacement Project
San Diego Gas & Electric Company
San Diego County, California
AECOM Reference No. 60597643

Photo Documentation
San Diego Gas and Electric - TL 649 Vibration Assessment
Chula Vista, California

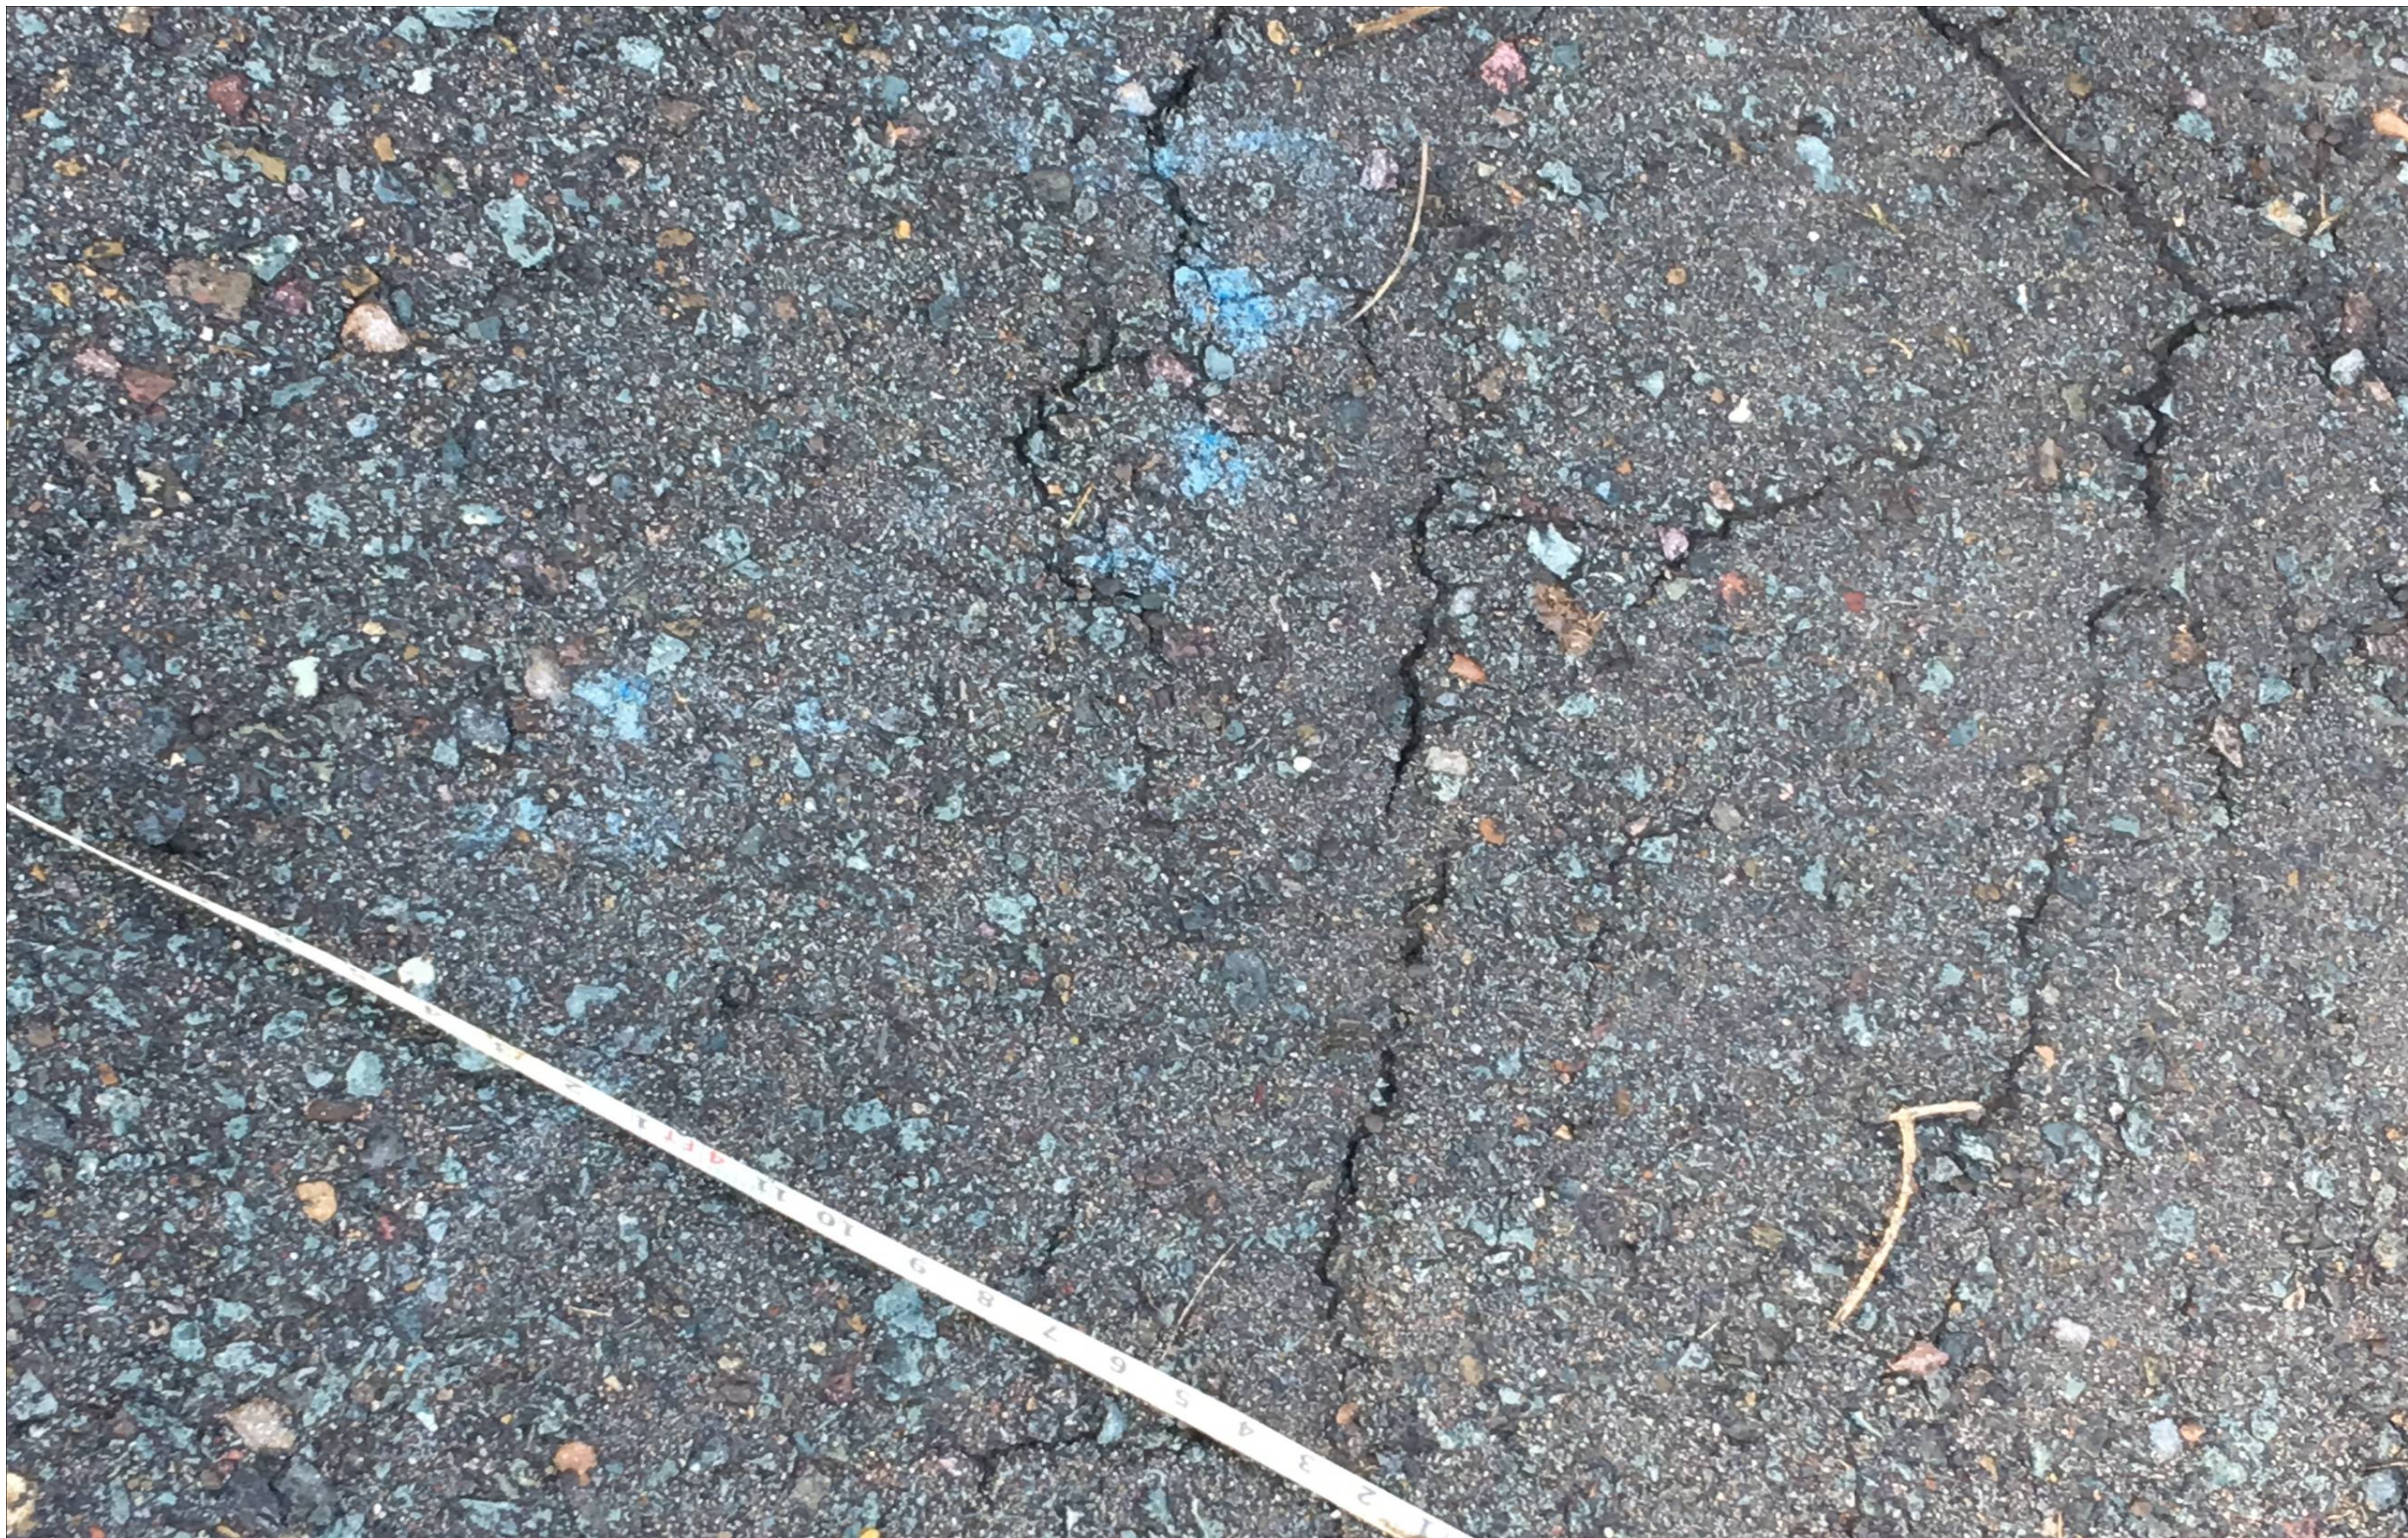
Existing distress in asphalt concrete near Pole 18

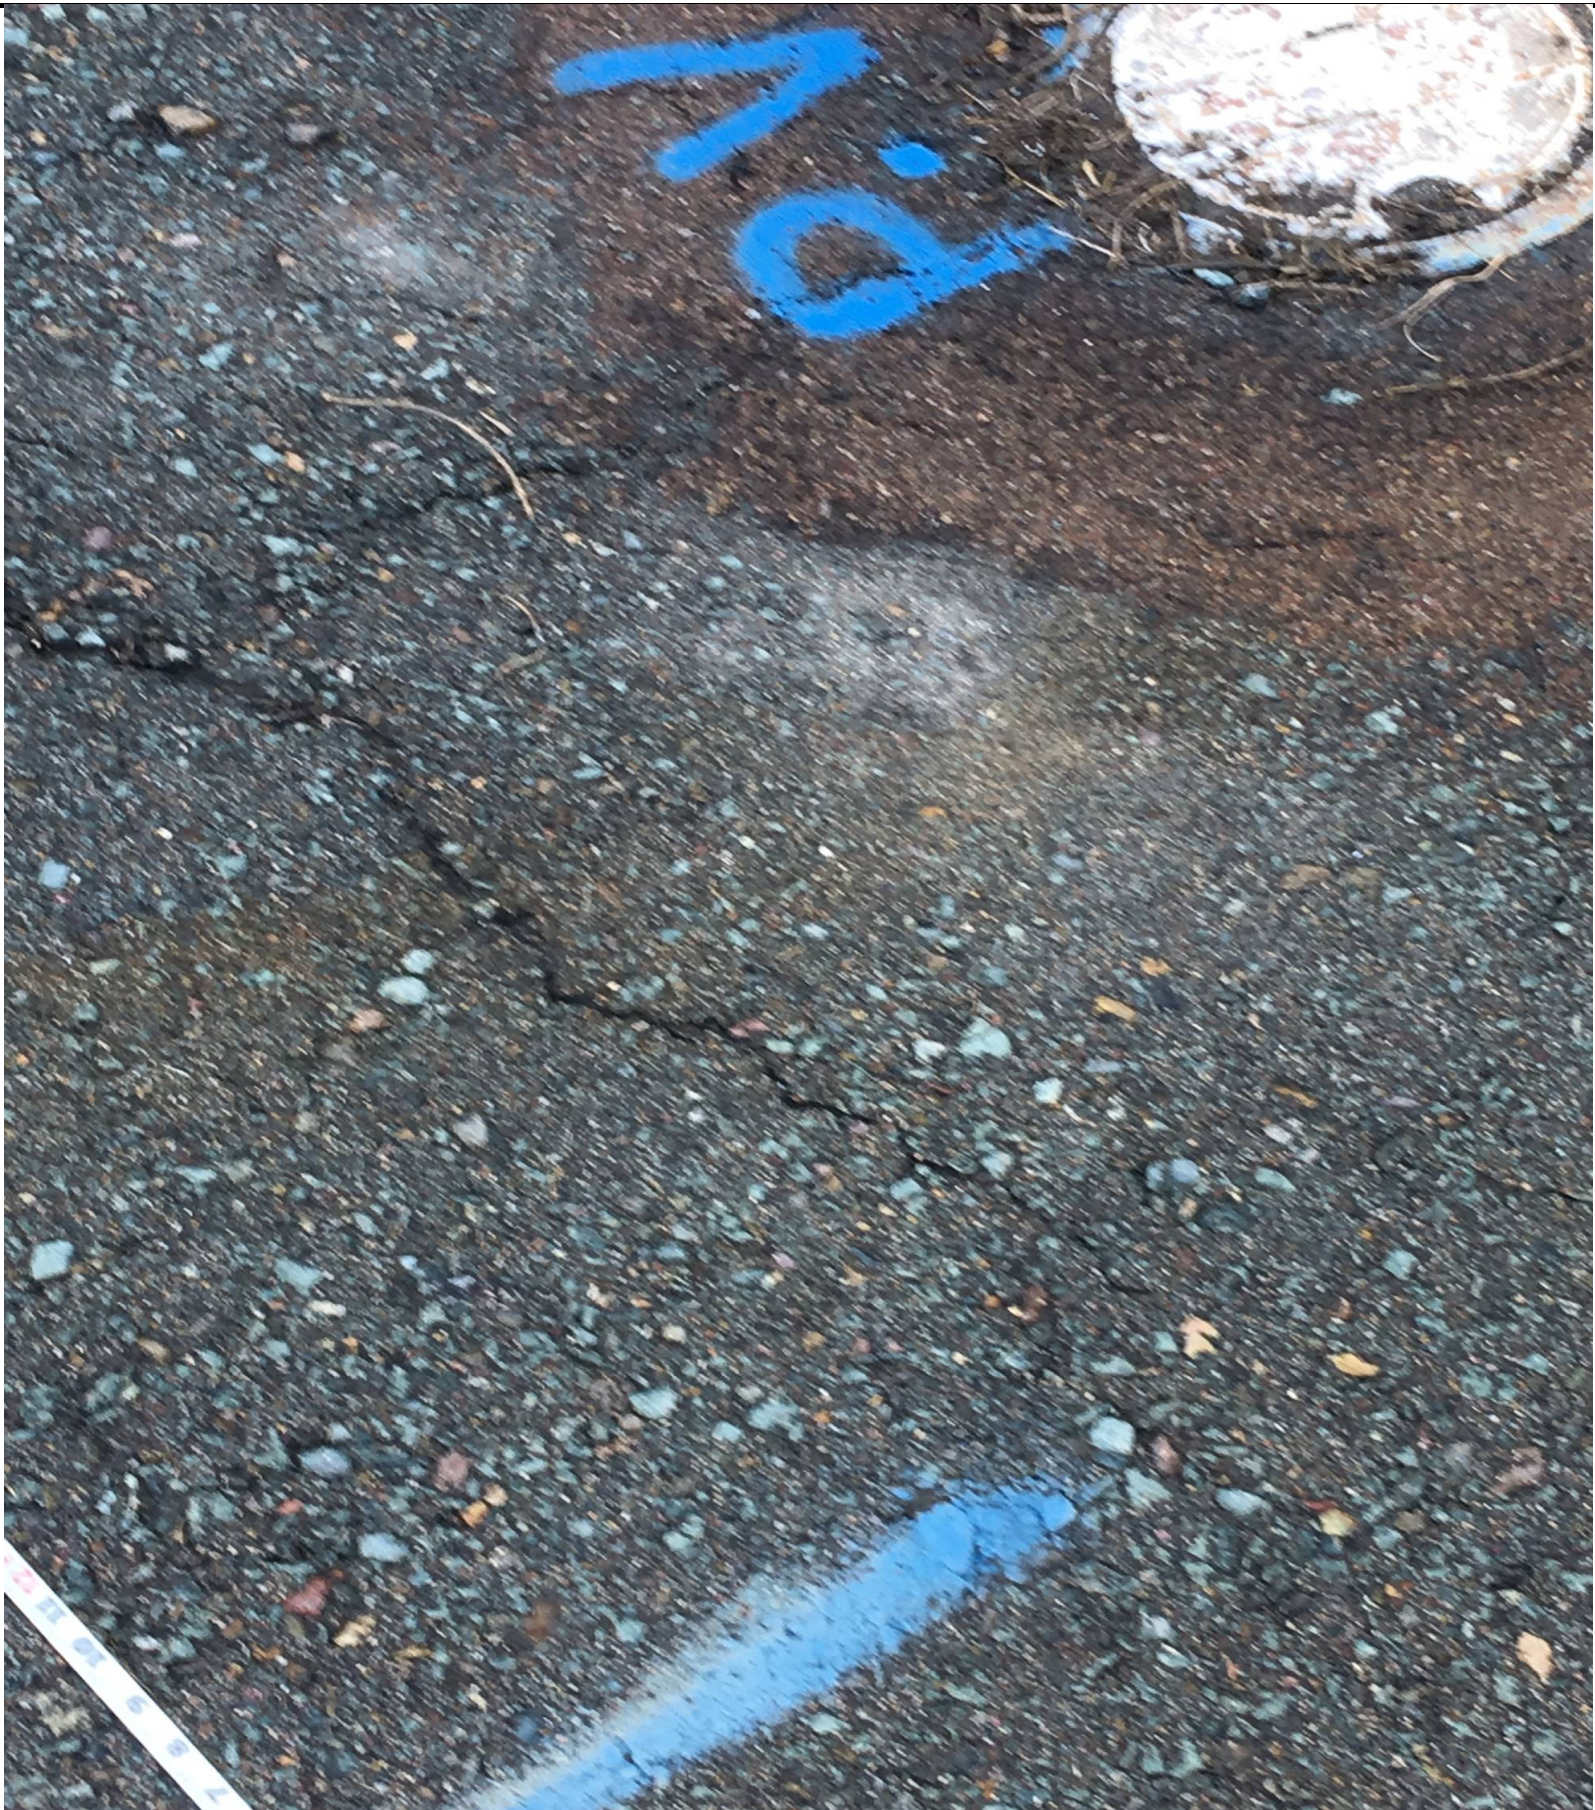
Existing distress in asphalt concrete near Pole 18

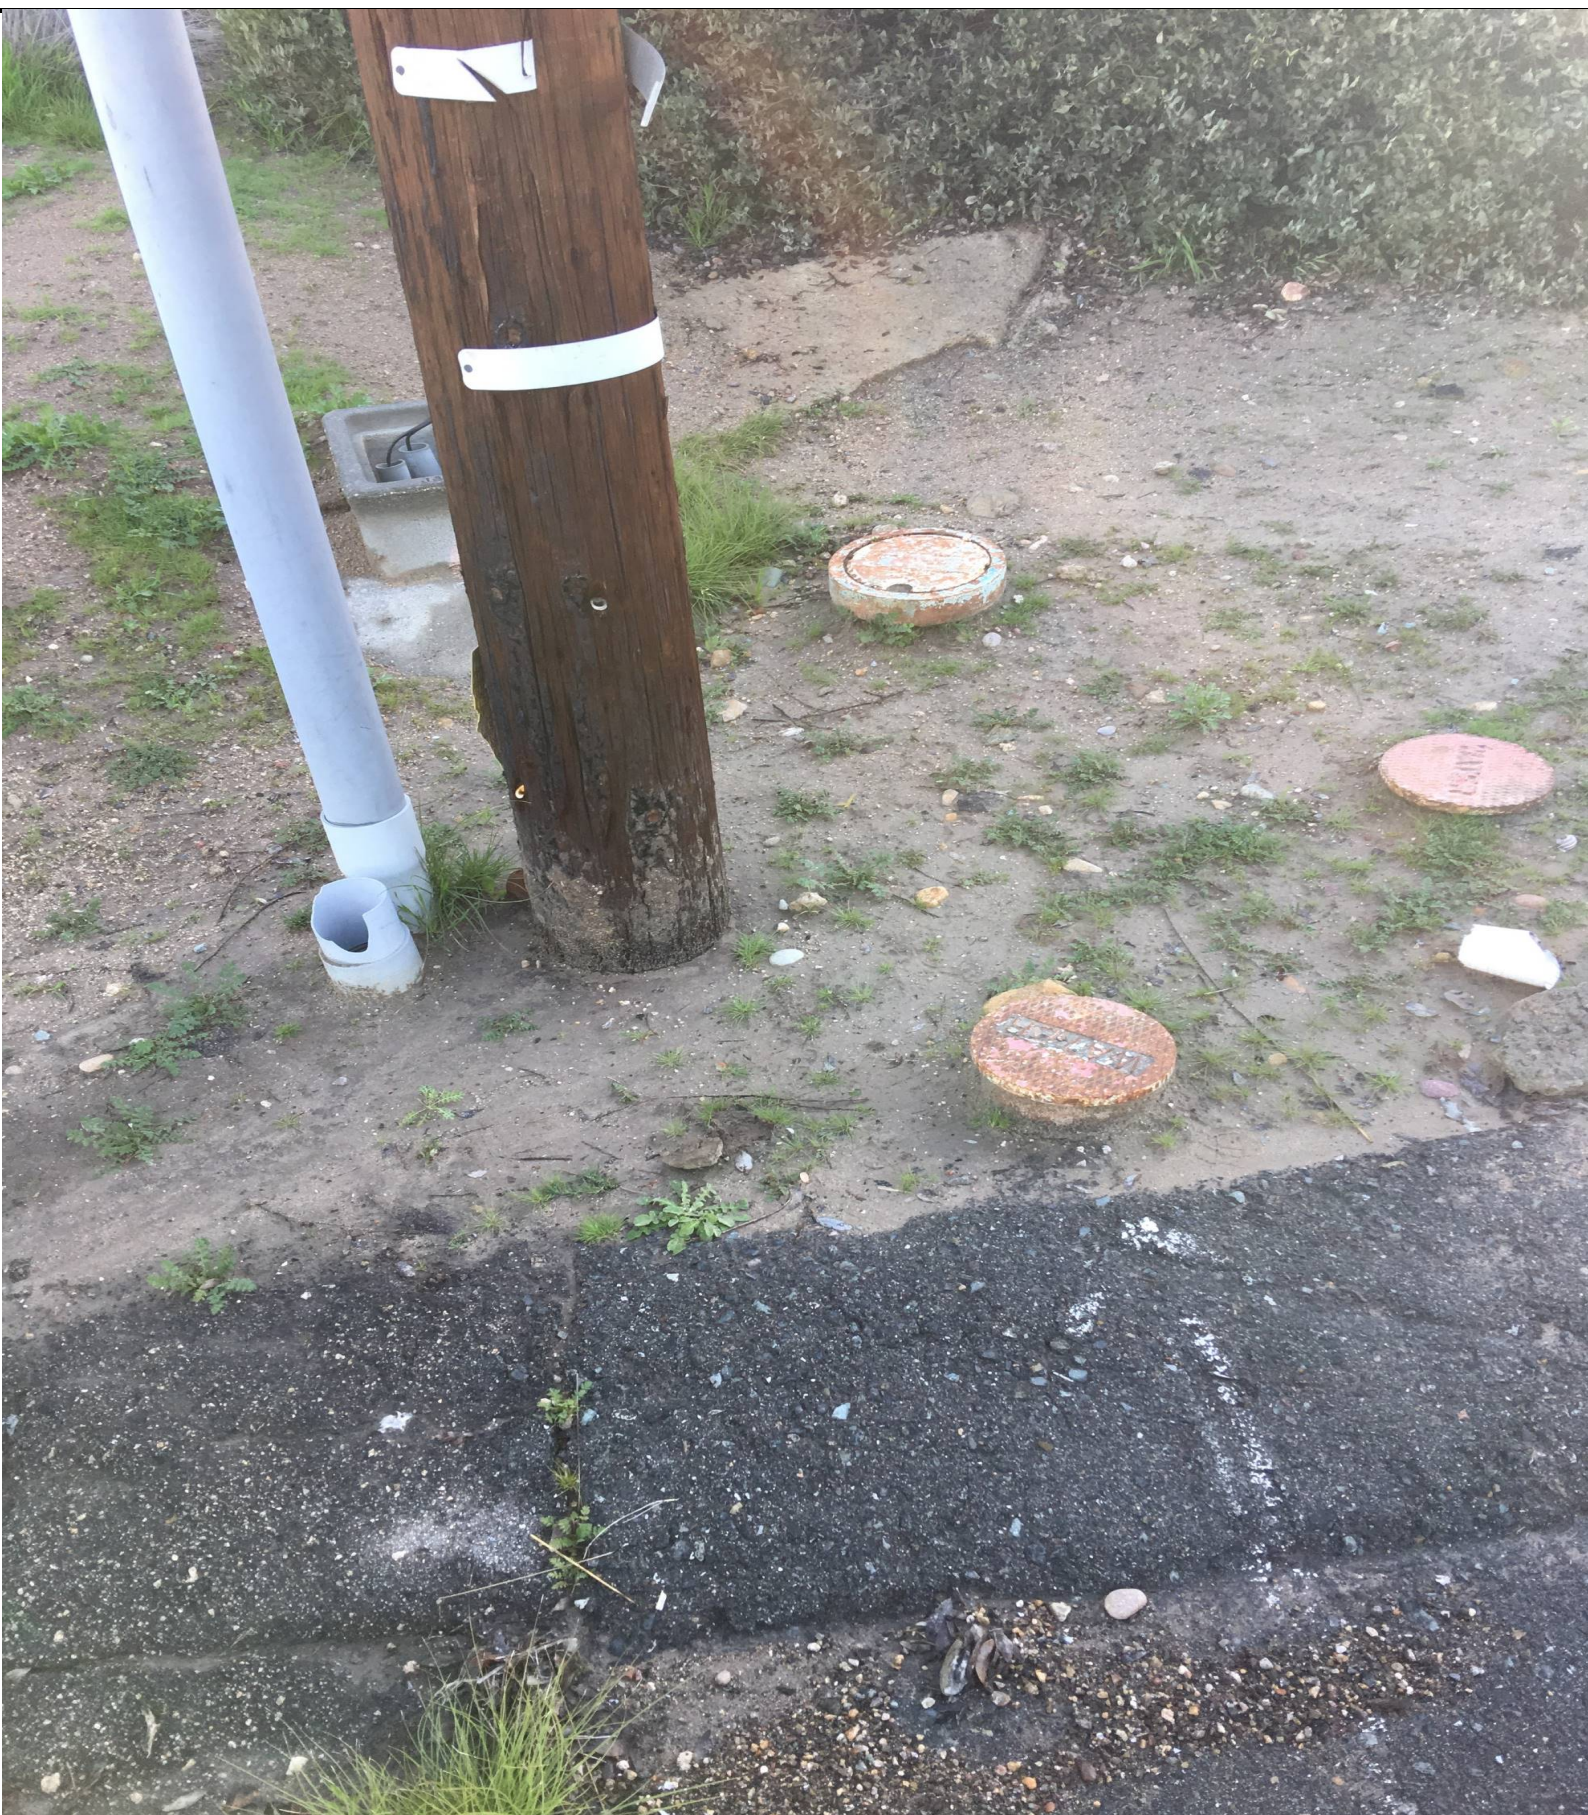
Minor water lines near Pole 18.1

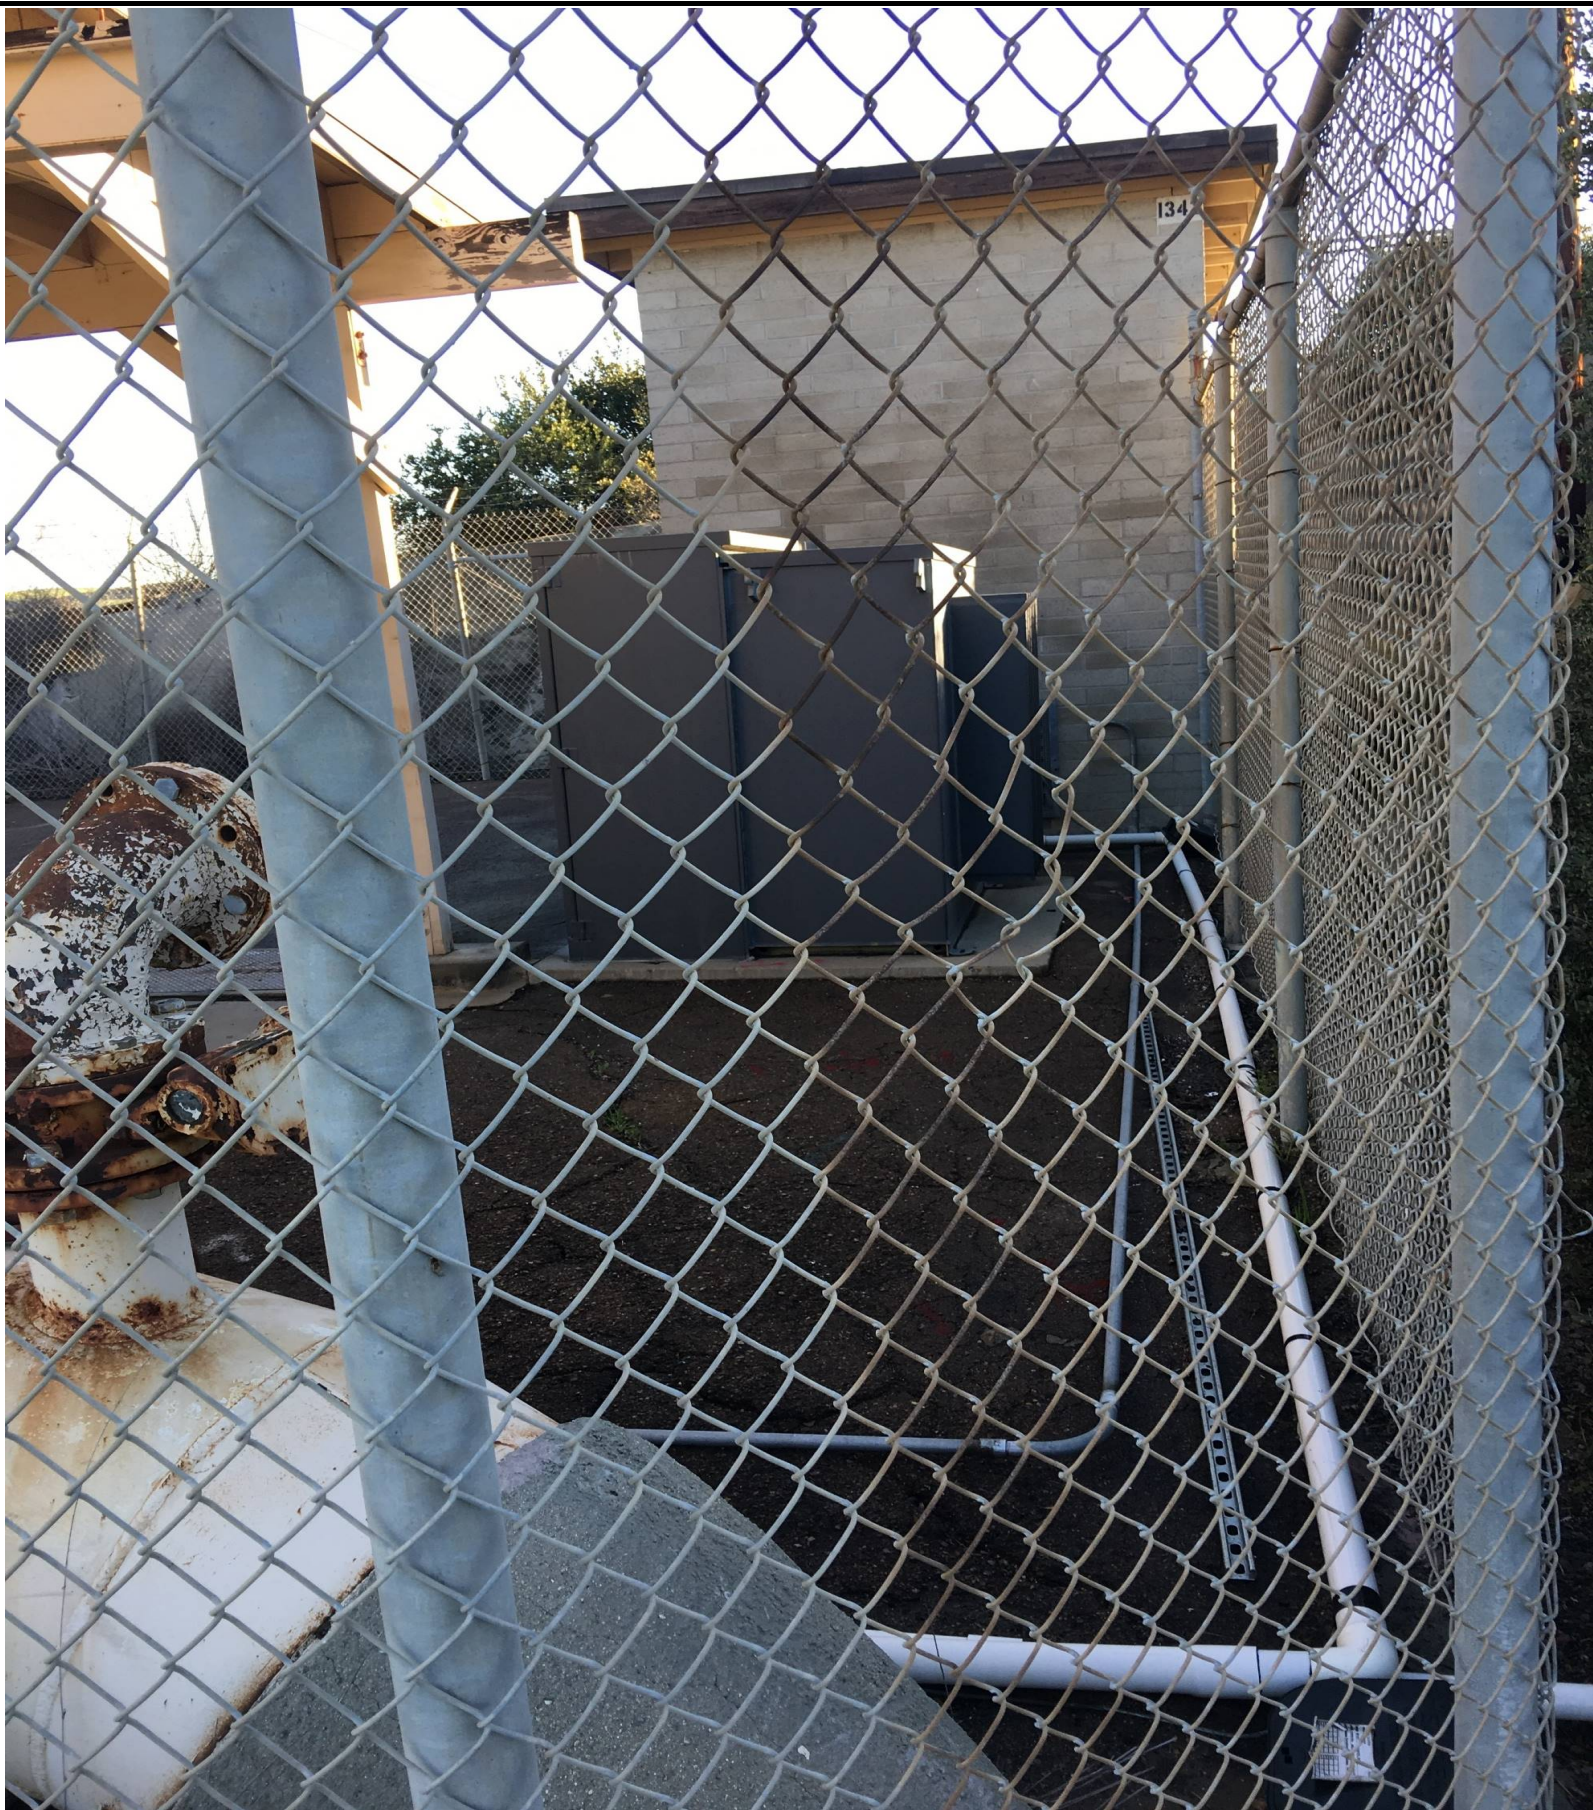
Electrical transformer within pipe and pump structure

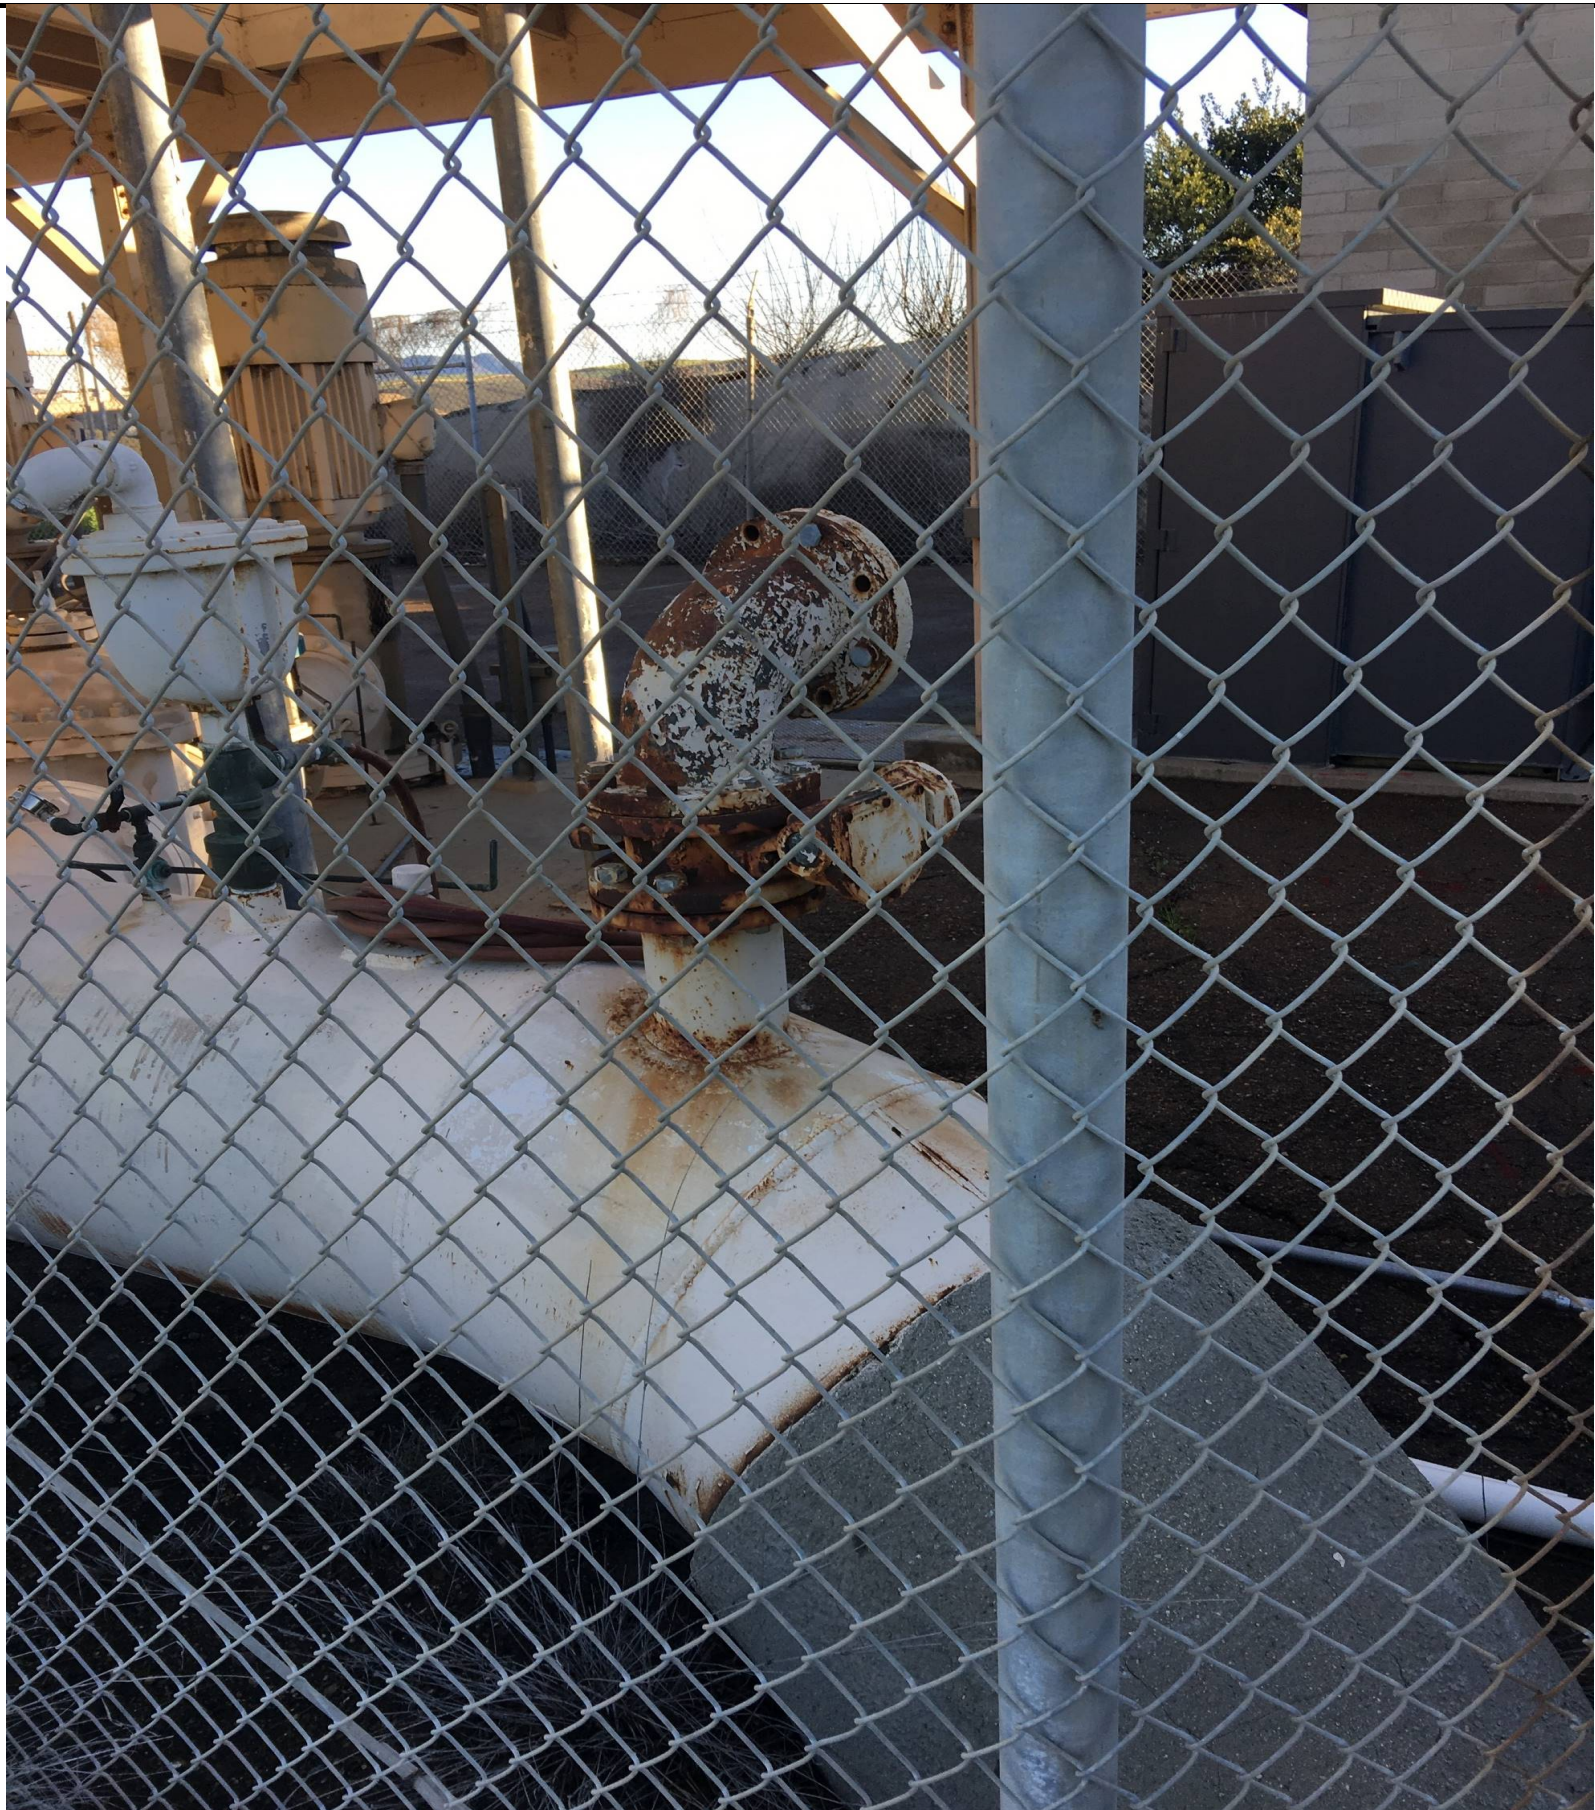
View of pipes within pipe and pump structure near Pole 18.1

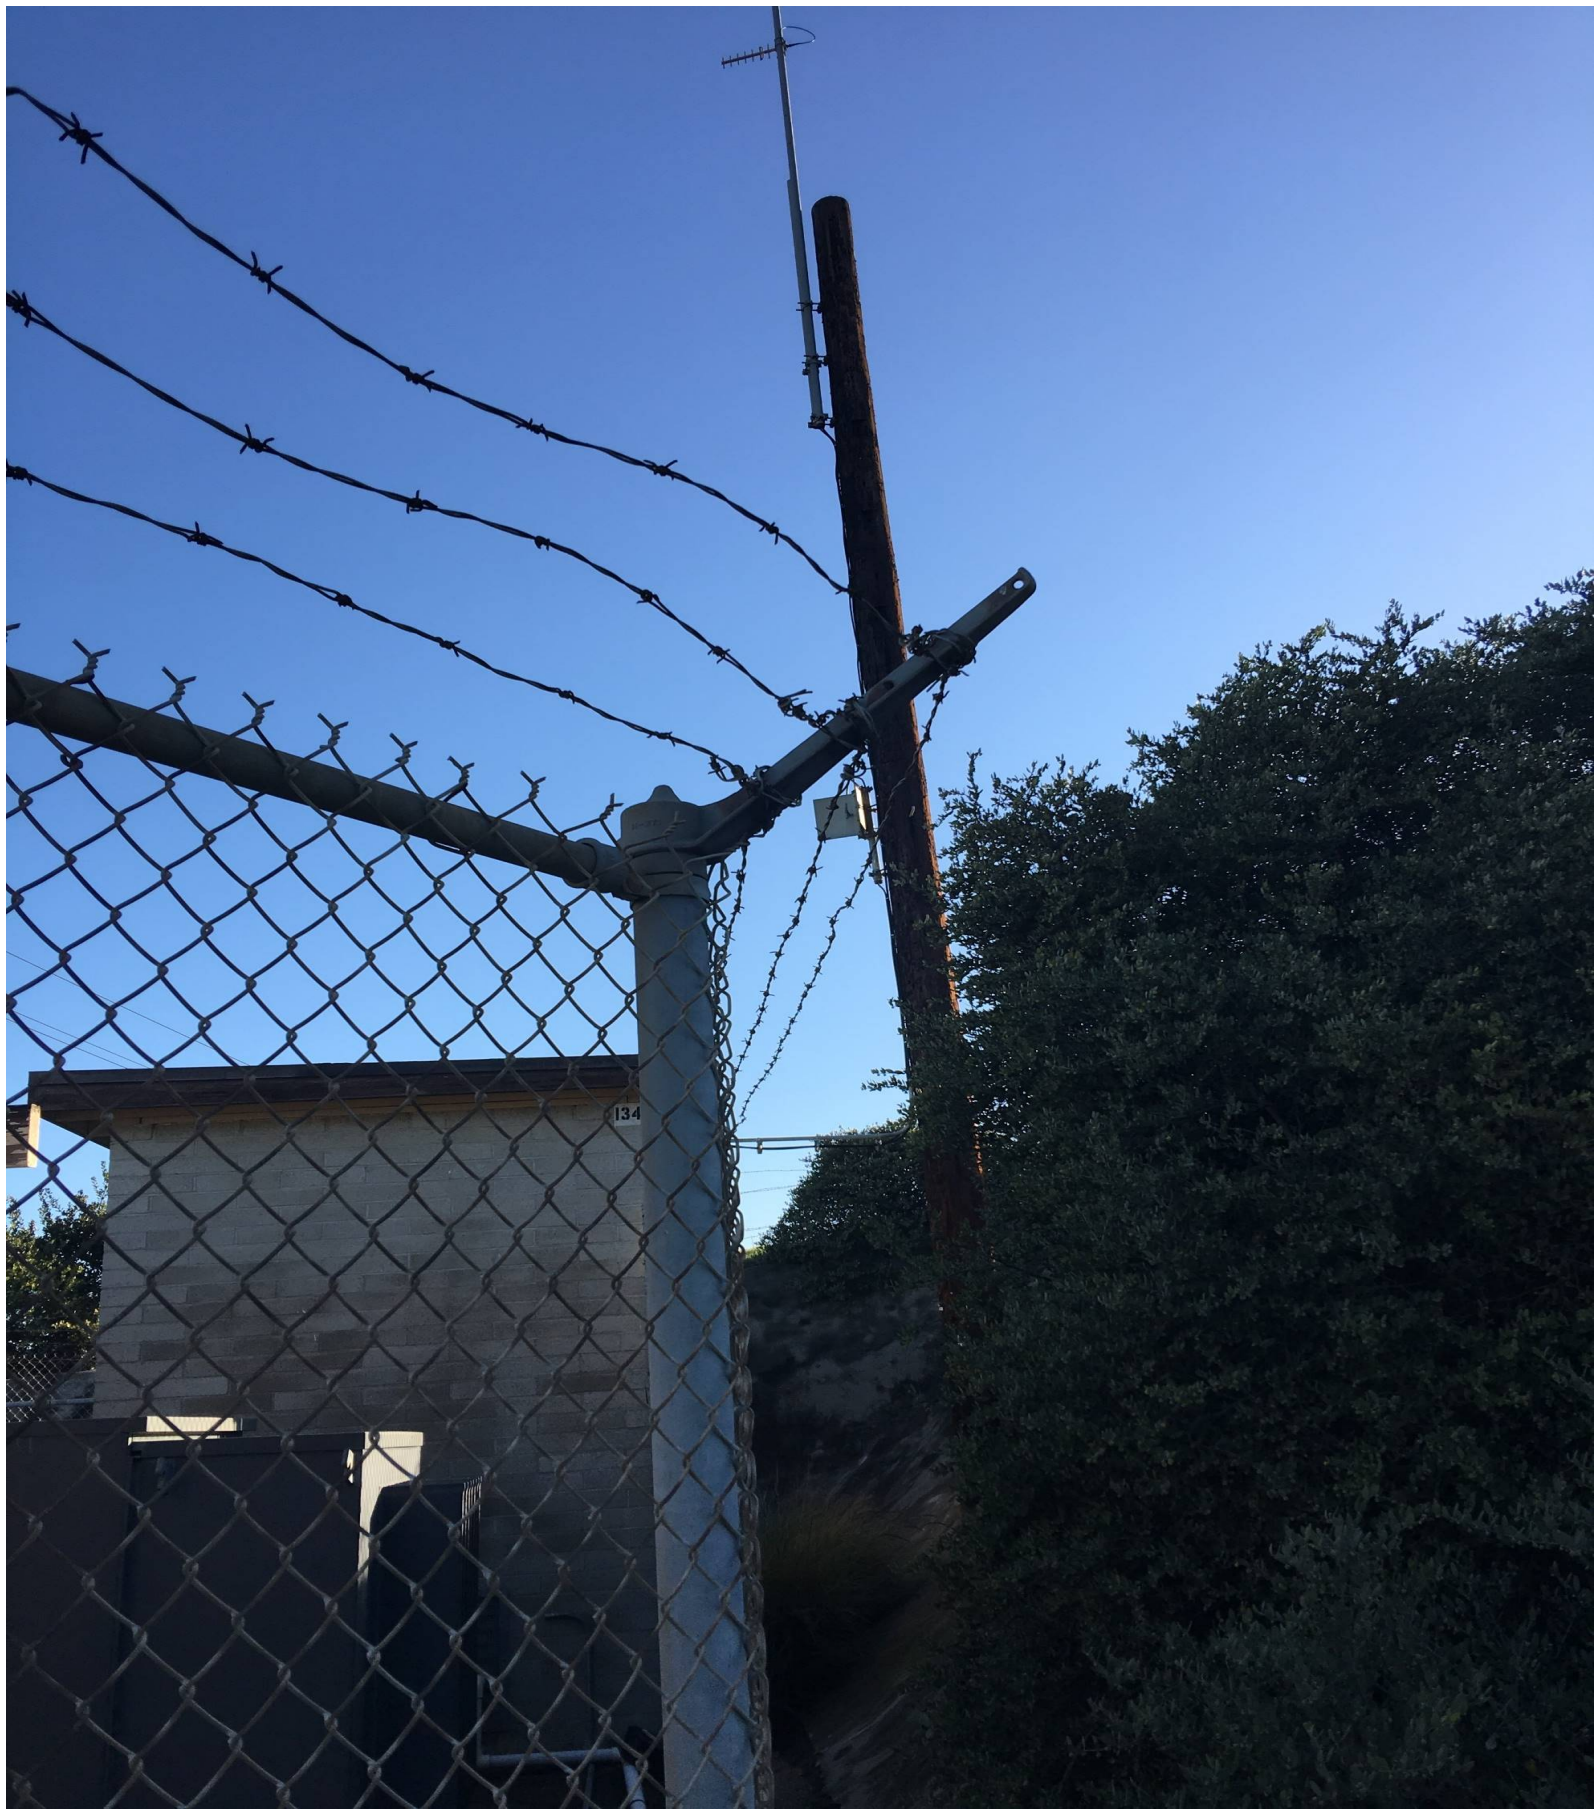
fencing and pole around pipe and pump structure

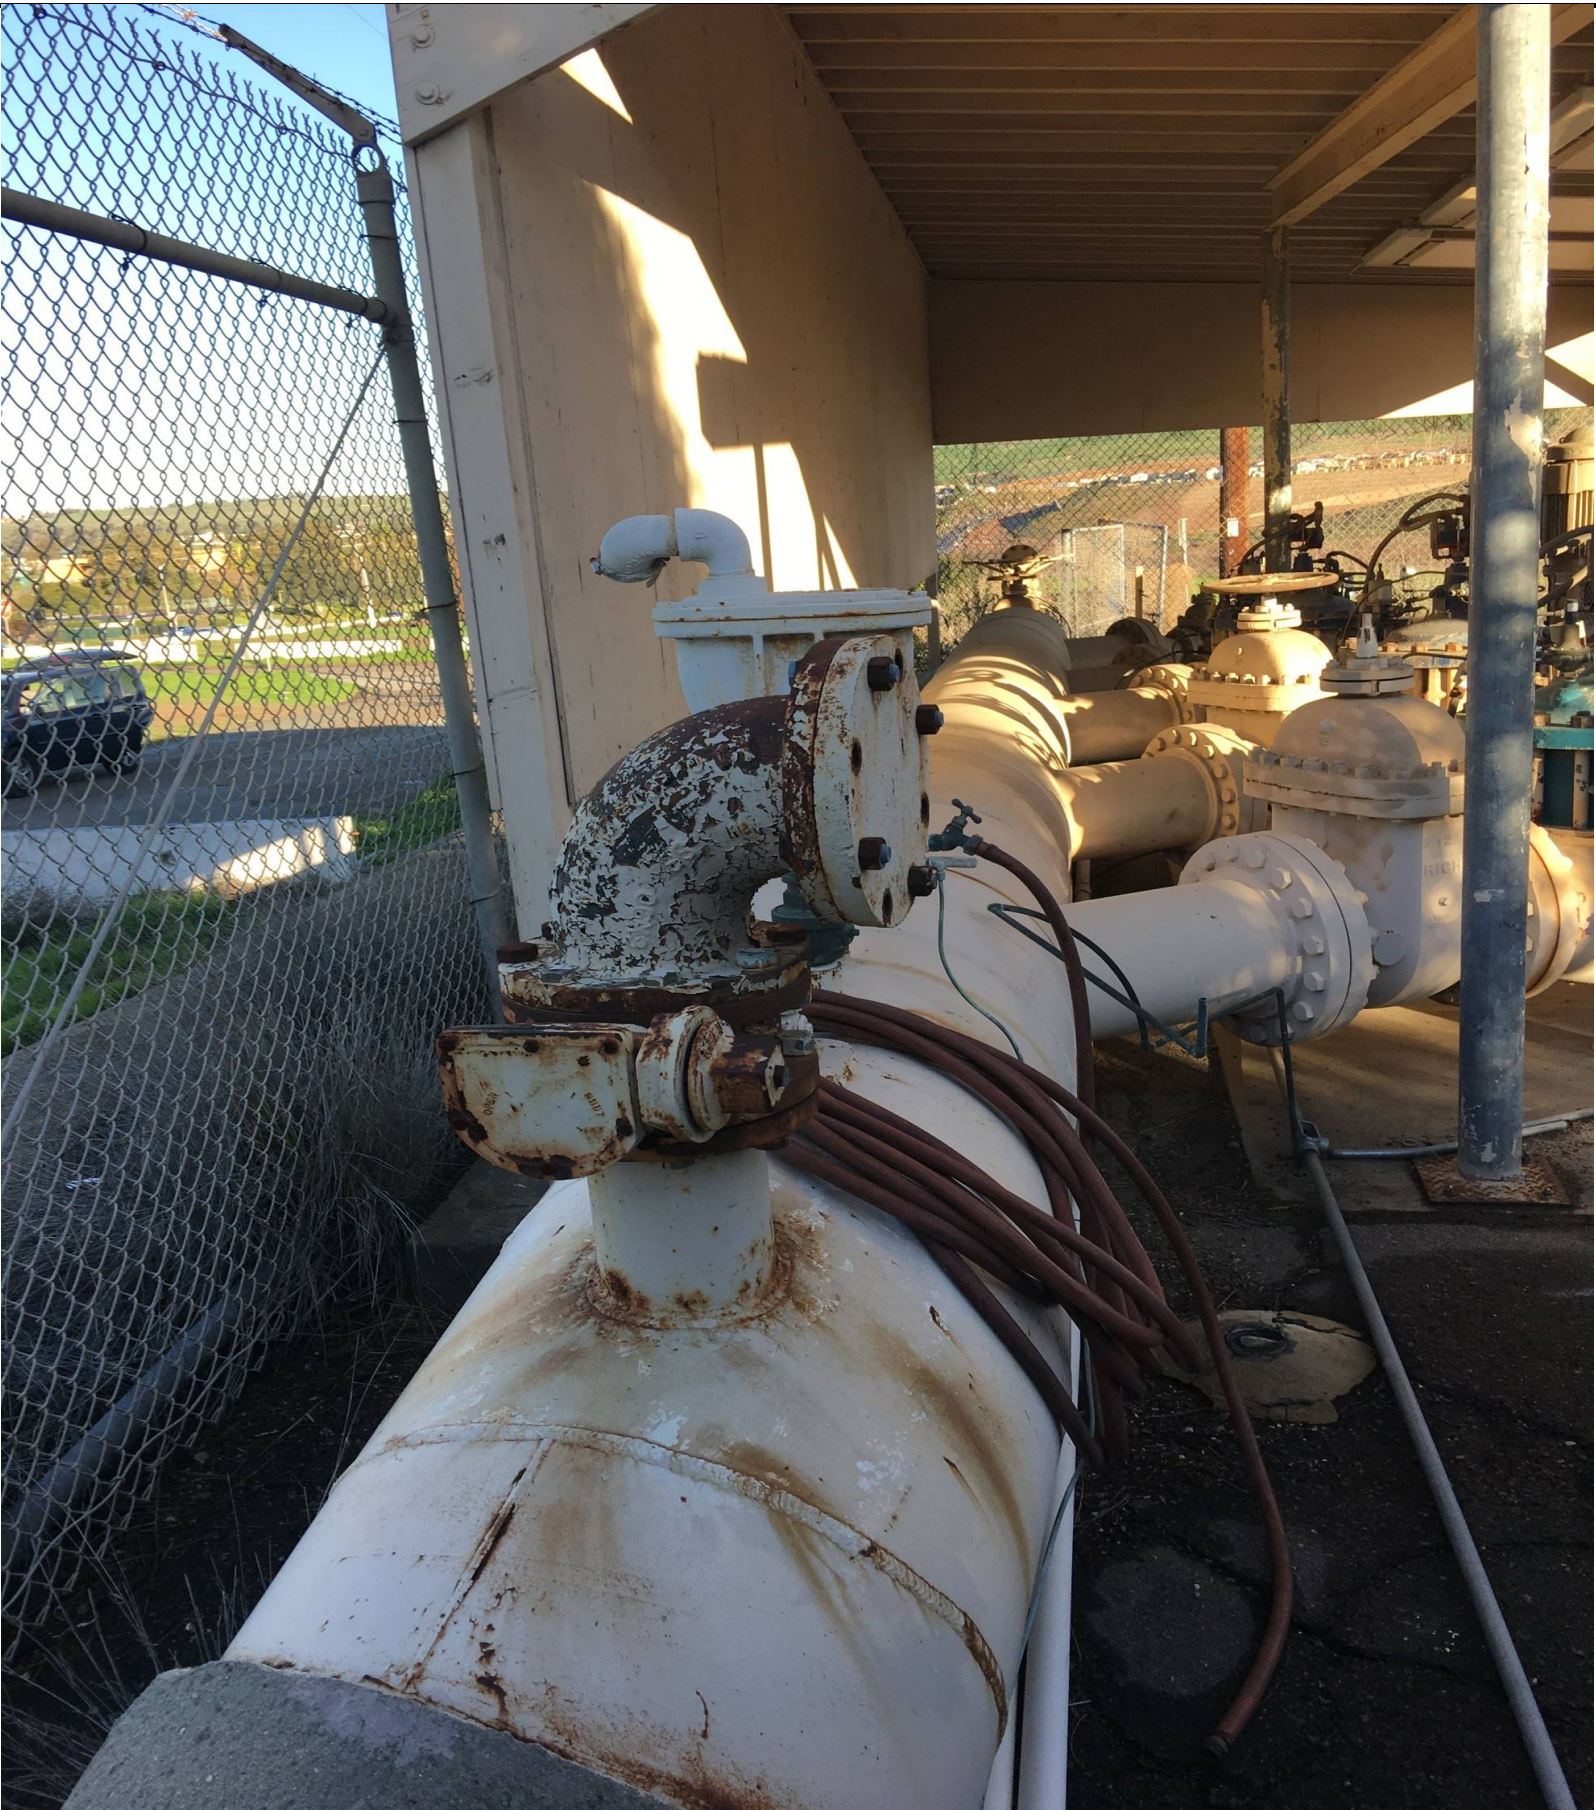
Pipes and pumps looking west near Pole 18.1
